Inspection Report Minerals Regulatory Program August 10, 2010

Mine Name: UDOT Beck Street Quarry	Permit Number: M/011/0003
Operator Name: Utah Dept of Transportation	Inspection Date: April 24, 2010
Inspector(s): L Heppler	Time: 11:00 am
Other Participants: none	Mine Status: Active

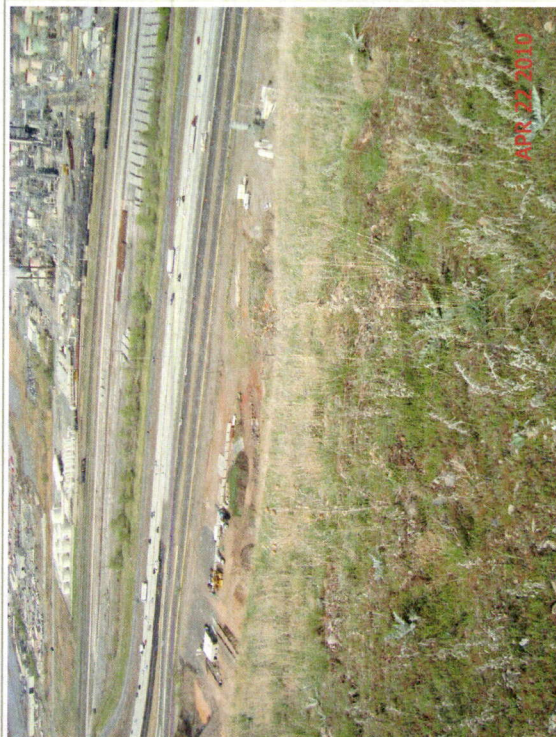
View towards base – Note Temporary crushing equipment on right center of photo (also note - base of adjacent mining permit)

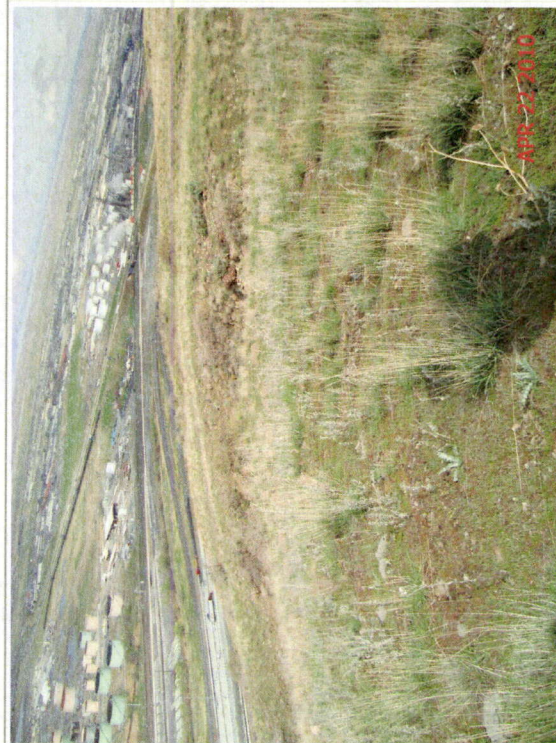
Upper portion of Mine site - undisturbed
